# Orion Capsule Parachute Assembly System (CPAS) Main and Drogue Canopy Instrumentation

Reefing systems are often used in parachute systems to control loading and inflation of the canopies. These systems typically use pyrotechnic cutters to sever lines to progress through the staging. Existing cutters have been used for more than 50 years and have been proven adequate through countless demands. These cutters must survive and operate through severe environments that include a large snatch load at deployment and random vibration through the stage. In lieu of extensive drop test campaigns, future cutters will need to be ground tested to environments which are representative of the flight environments. The Capsule Parachute Assembly System (CPAS) developed sensors that capture accelerations and rates in three axes during parachute deployment and operation. These sensors have mass properties, size, and an attachment method similar to existing reefing line cutter assemblies, maximizing the usability of the data. Various risk reduction steps were taken to minimize any negative effects to the qualification parachute system and to increase the likelihood of collecting usable data. 24 senso

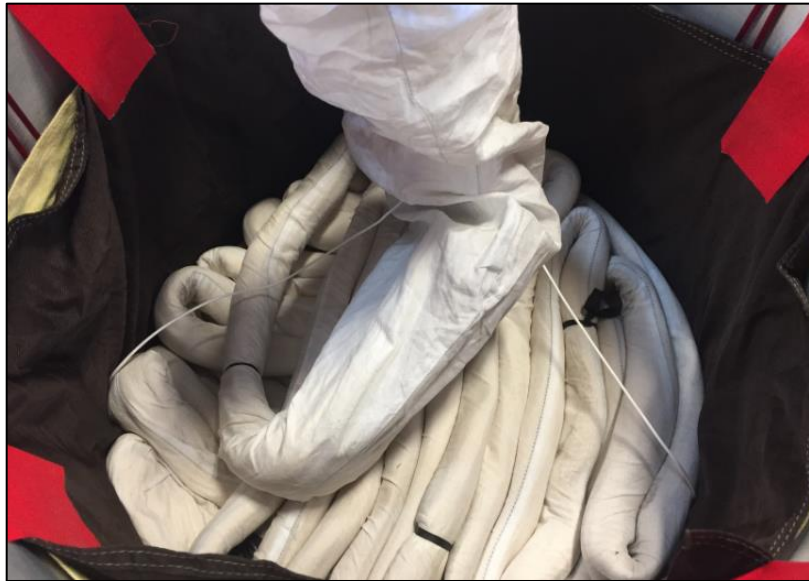
**Fig. 5 Sensor activation lanyard in Drogue parachute.**

The activation method for the RLCES was designed for minimal impact to the qualification parachutes. Flight-like packing and integration of the Main and mortar-deployed Drogue parachutes, along with snag hazard concerns, required the activation method be completely self-contained inside the deployment bag. Additionally, it was desired to activate the sensors as early as possible in the deployment so that the system could boot up and begin collecting data as early as possible. This required a length of the Spectra activation lanyard to be pulled past parachute material. Simulator lanyards (with no sensors) were installed in the qualification Main and Drogue parachutes on CQT4-5 (Cluster Qualification Test), as seen in the Drogue in Fig. 5. The primary test objectives were to observe any damage

All 8 simulator lanyards performed as expected. The entire length of installed lanyard remained fixed to the attach point at post-test inspection. Additionally, there was no indication of friction burns or other damage to the qualification asset. This provided confidence that the sensors could be activated without impacting the qualification parachutes.

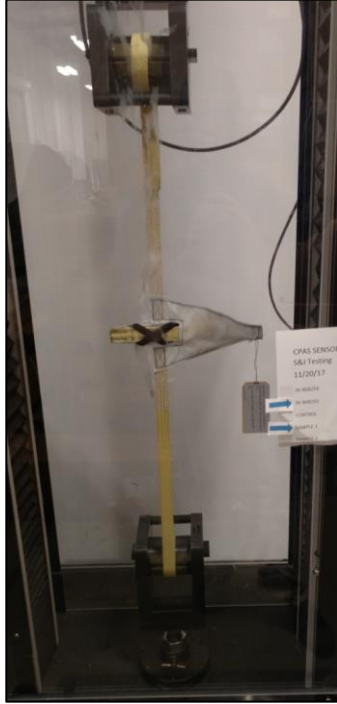
**Fig. 6 Sensor pocket seam and joint testing.**

Stitching, knotting, joining, or otherwise affecting raw textile materials can degrade the ultimate strength of that material. Introduction of the RLCEs into the canopies required the addition of custom pockets which were sewn into the parachute. Testing was required to demonstrate that joining the pocket materials to the parachute structural grid did not significantly degrade the structural capability of the parachute. Since these pockets are slightly different from the flight cutter pockets (located on the outside of the canopy), samples were pull tested, as seen in Fig. 6, and results showed that the addition of the pockets did not significantly degrade the parachutes.
